Products Review

and SERVICE NEWS

DECEMBER, 1946

PRODUCT SERVICE

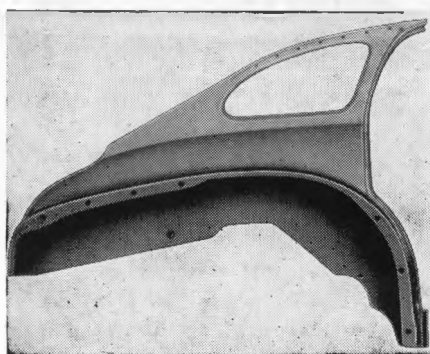
Fig. 2

Normally, when a rear wheelhousing, "A" Fig. 1, is damaged, the complete rear quarter side outer panel, shown in Fig. 2, has to be

replaced because the wheelhousing is not serviced separately.

Experience has proven that a damaged rear wheelhousing can be removed and only the wheelhouse section of a rear quarter panel in-

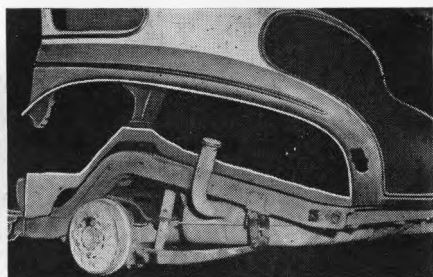
FIG. 7

9. Fig. 7 shows an exterior view of the body after the wheelhouse is removed and Fig. 8 an interior view.
